VEHICLE CONDITION REPORT

VIN	██████████	Seats	5	Fuel Type	Benzin
Year	2008	Body Type / Doors	Stufenheck/4	Turbo / Supercharged:	NA
Make	SUBARU	Exterior Colour	Blau	Eng. Cyl. / Arrange	4/Boxer
Model	Impreza	Paint Category		Engine Displacement	1994
Series	Impreza WRX STI / 265	Drive / Gears / Trans	Allrad permanent / 6/Schaltgetriebe	Interior Colour	Schwarz
Odometer	101025	Maintenance	1	Maintenance Date	14/06/2003
Licence Plate	██████████	Company Name	██████████	Inspection Loc.	██████████
Parking Bay		Address		Address	
Arrival Date	18/03/2022 16:23:39	City		City	
		State / Province, Zip		State / Province, Zip	
		Phone #		Phone #	
Inspector No.	██████████	Assgn. Date		CR Post Date	
Registration Date	01/06/2008	Insp. Date	18/03/2022 16:23:39	Print Date

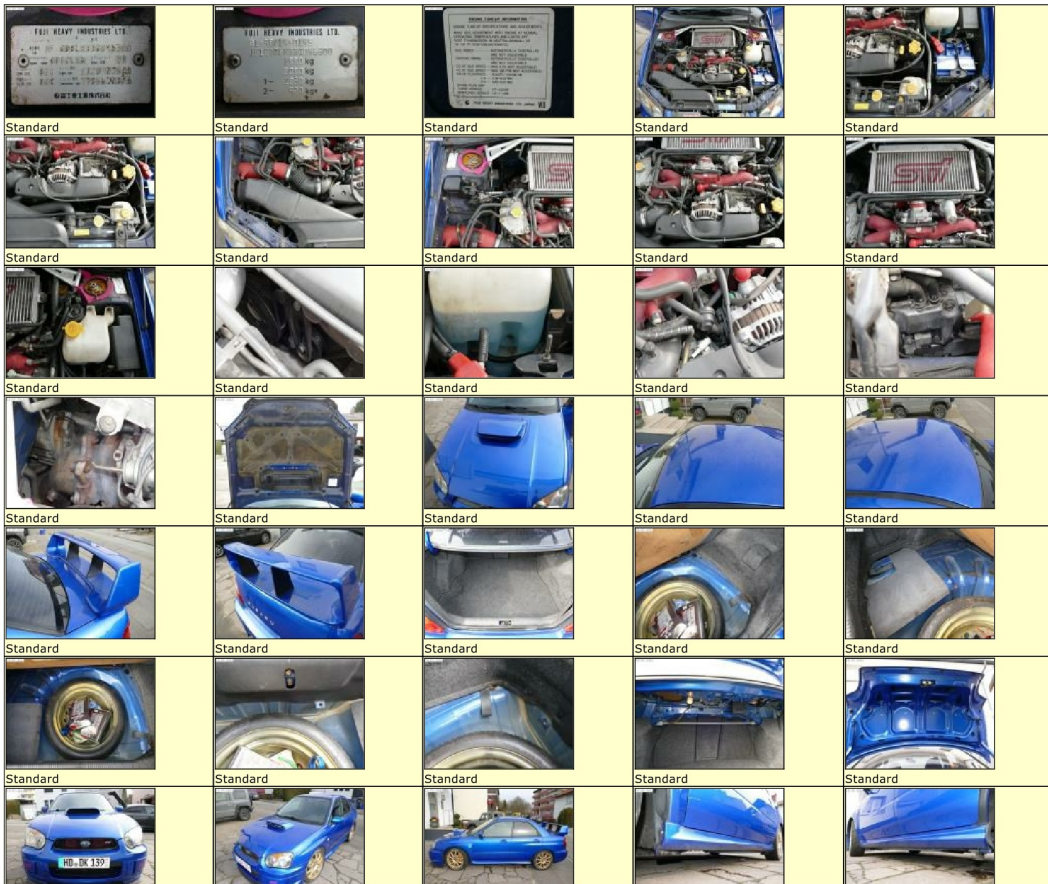
Ref	Part	Type	Severity	Repair Mode	Cause	Paint Labour Cost	Repair Labour Cost	Labour Cost	Parts Cost	Net Cost	Dep.(%)	Dep. Amt.	Total Cost
1	Side Panel - Left Rear(Right)	Rusty	>8cm - 10cm	NA	SV	€ 0.00	€ 0.00	€ 0.00	€ 0.00	€ 0.00	55.00%	€ 0.00	€ 0.00
2	Rocker Panel - Right Rear	Bent	>6cm - 8cm	NA	SV	€ 0.00	€ 0.00	€ 0.00	€ 0.00	€ 0.00	55.00%	€ 0.00	€ 0.00
3	Rocker Panel - Left Rear	Rusty	>4cm - 6cm	NA	SV	€ 0.00	€ 0.00	€ 0.00	€ 0.00	€ 0.00	55.00%	€ 0.00	€ 0.00
4	Fender / Wing - Right Front	Rusty	>4cm - 6cm	NA	SV	€ 0.00	€ 0.00	€ 0.00	€ 0.00	€ 0.00	55.00%	€ 0.00	€ 0.00
5	Fender / Wing - Right Front	Scratched	>3cm - 4cm	NA	SV	€ 0.00	€ 0.00	€ 0.00	€ 0.00	€ 0.00	55.00%	€ 0.00	€ 0.00
6	Bumper - Front(Right)	Scuffed	>6cm - 8cm	NA	SV	€ 0.00	€ 0.00	€ 0.00	€ 0.00	€ 0.00	55.00%	€ 0.00	€ 0.00
7	Front Spoiler - Front	Scuffed	>8cm - 10cm	NA	SV	€ 0.00	€ 0.00	€ 0.00	€ 0.00	€ 0.00	55.00%	€ 0.00	€ 0.00
8	Hood / Bonnet - Front	Stone/Paint Chipped	>3cm - 4cm	NA	SV	€ 0.00	€ 0.00	€ 0.00	€ 0.00	€ 0.00	55.00%	€ 0.00	€ 0.00

9	Headlamp - Right Front(Right)	Other - See Notation	Other - See Notation	NA	SV	€ 0.00	€ 0.00	€ 0.00	€ 0.00	€ 0.00	55.00%	€ 0.00	€ 0.00
10	Headlamp - Left Front(Left)	Other - See Notation	Other - See Notation	NA	SV	€ 0.00	€ 0.00	€ 0.00	€ 0.00	€ 0.00	55.00%	€ 0.00	€ 0.00
11	Carrisserie - Technical(Left)	Stone/Paint Chipped	>1cm - 2cm	NA	SV	€ 0.00	€ 0.00	€ 0.00	€ 0.00	€ 0.00	55.00%	€ 0.00	€ 0.00
12	Fender / Wing - Left Front	Dented, No Pnt Dmg	>2cm - 3cm	NA	SV	€ 0.00	€ 0.00	€ 0.00	€ 0.00	€ 0.00	55.00%	€ 0.00	€ 0.00
13	Door - Left Front	Dented, No Pnt Dmg	>1cm - 2cm	NA	SV	€ 0.00	€ 0.00	€ 0.00	€ 0.00	€ 0.00	55.00%	€ 0.00	€ 0.00
14	Door - Left Rear	Dented, No Pnt Dmg	>1cm - 2cm	NA	SV	€ 0.00	€ 0.00	€ 0.00	€ 0.00	€ 0.00	55.00%	€ 0.00	€ 0.00
15	Side Panel - Left Rear(Right)	Stone/Paint Chipped	>3cm - 4cm	NA	SV	€ 0.00	€ 0.00	€ 0.00	€ 0.00	€ 0.00	55.00%	€ 0.00	€ 0.00
16	Boot Lid - Rear	Dented w/ Paint Dmg	>1cm - 2cm	NA	SV	€ 0.00	€ 0.00	€ 0.00	€ 0.00	€ 0.00	55.00%	€ 0.00	€ 0.00

17	Bumper - Rear(Right)	Scuffed	>2cm - 3cm	NA	SV	€ 0.00	€ 0.00	€ 0.00	€ 0.00	€ 0.00	55.00%	€ 0.00	€ 0.00
18	Door - Right Rear(Right)	Dented, No Pnt Dmg	>1cm - 2cm	NA	SV	€ 0.00	€ 0.00	€ 0.00	€ 0.00	€ 0.00	55.00%	€ 0.00	€ 0.00
19	Aluminium rim - Right Rear(Right)	Scuffed	>8cm - 10cm	NA	SV	€ 0.00	€ 0.00	€ 0.00	€ 0.00	€ 0.00	55.00%	€ 0.00	€ 0.00
20	Aluminium rim - Left Rear(Left)	Scuffed	>8cm - 10cm	NA	SV	€ 0.00	€ 0.00	€ 0.00	€ 0.00	€ 0.00	55.00%	€ 0.00	€ 0.00
21	Aluminium rim - Left Front	Scuffed	>6cm - 8cm	NA	SV	€ 0.00	€ 0.00	€ 0.00	€ 0.00	€ 0.00	55.00%	€ 0.00	€ 0.00
22	Protection Strip - Right Rear	Scuffed	>4cm - 6cm	NA	SV	€ 0.00	€ 0.00	€ 0.00	€ 0.00	€ 0.00	55.00%	€ 0.00	€ 0.00
23	Rocker Panel - Right Front(Left)	Dented, No Pnt Dmg	>2cm - 3cm	NA	SV	€ 0.00	€ 0.00	€ 0.00	€ 0.00	€ 0.00	55.00%	€ 0.00	€ 0.00
24	Trim-Cover - Rear	Loose	Other - See Notation	NA	SV	€ 0.00	€ 0.00	€ 0.00	€ 0.00	€ 0.00	55.00%	€ 0.00	€ 0.00

25	Seat - Left Front	Rusty	>2cm - 3cm	NA	SV	€ 0.00	€ 0.00	€ 0.00	€ 0.00	€ 0.00	55.00%	€ 0.00	€ 0.00
26	Door Handle - Left Front(Left)	Missing	Replace	RR	SV	€ 0.00	€ 9.00	€ 9.00	€ 11.37	€ 20.37	0.00%	€ 0.00	€ 20.37
27	Seat - Right Front	Rusty	Other - See Notation	NA	SV	€ 0.00	€ 0.00	€ 0.00	€ 0.00	€ 0.00	55.00%	€ 0.00	€ 0.00
28	Dash Panel - Forward	Missing	Other - See Notation	NA	SV	€ 0.00	€ 0.00	€ 0.00	€ 0.00	€ 0.00	0.00%	€ 0.00	€ 0.00
29	Circuit de freinage - Technical	Stone/Paint Chipped	Other - See Notation	NA	SV	€ 0.00	€ 0.00	€ 0.00	€ 0.00	€ 0.00	55.00%	€ 0.00	€ 0.00
30	Tail Lamp - Right Rear	Other - See Notation	Other - See Notation	NA	SV	€ 0.00	€ 0.00	€ 0.00	€ 0.00	€ 0.00	55.00%	€ 0.00	€ 0.00
Total						€ 0.00	€ 9.00	€ 9.00	€ 11.37	€ 20.37		€ 0.00	€ 20.37

Ref	Comments
9	milchig
10	milchig

Am Fahrzeug wurde eine Lackschichtmessung vorgenommen und die Werte lagen innerhalb der Toleranz. Eine Nachlackierung des Fahrzeuges kann auf Grund des Alters aber nicht ausgeschlossen werden. Der bei der HU-Untersuchen fehlende DB-Eater wurde nachträglich verbaut. Eine Unterbodenkontrolle konnte auf Grund der Standortbedingungen nicht durchgeführt werden.
